Guildford Society Walking Audits

Guildford Society Transport Group,
September 2009

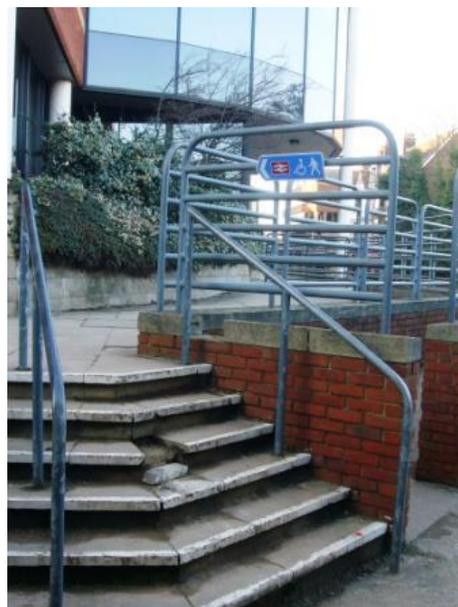
4. *Riverside.*

The sign immediately to the north of Friary Bridge (pictured) indicates that wheelchair users should go up a flight of steps. Not only is this bizarre, it also fails to indicate the need to turn left at the top of the steps. The existing sign should be moved from the railings to the wall facing the top of the steps.

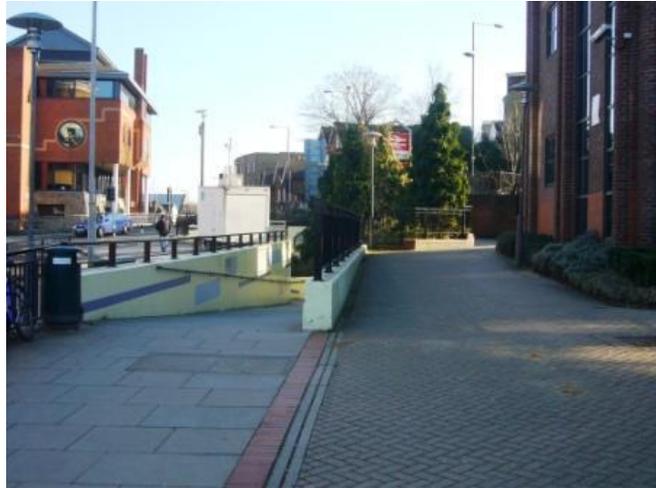
5. *Ramp to Bridge Street subway.*
Pictured.

There is a beautifully informative sign hidden on the left hand side of the wall in the centre of the picture. A “mirror image” of the sign is needed on the left hand wall.

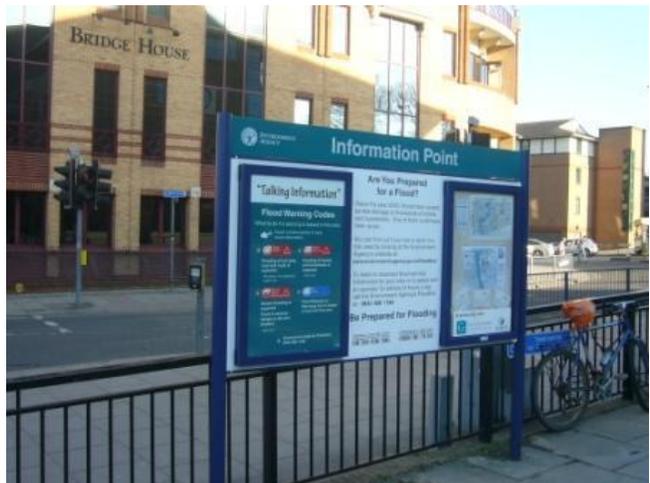
7. *Reverse direction.*

The first sign on the route is shown in the picture, partially hidden by the Flood Information Point and the bicycle. It should be moved to the decision point where the user would expect to find it - at the start of the railings 3 bays to the left.

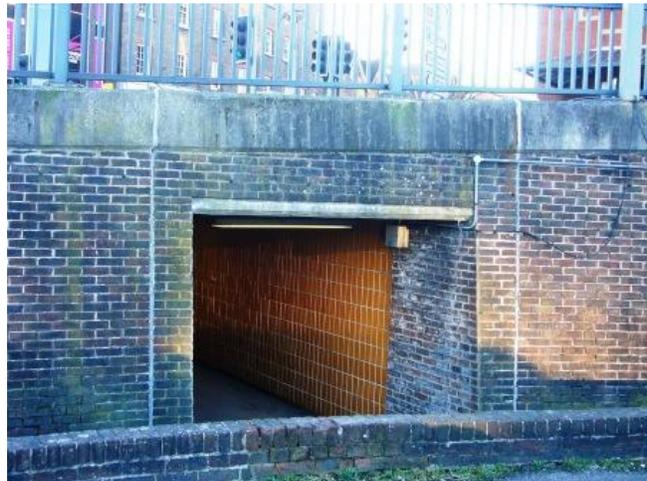
4. *Park Street subway (pictured).*

Sign to “Park Street” and “Farnham Road multi-storey car park”.
